# FACT SHEET

## Scary Pool Stories

Brought to you by the PHTA Recreational Water Quality Committee (RWQC)

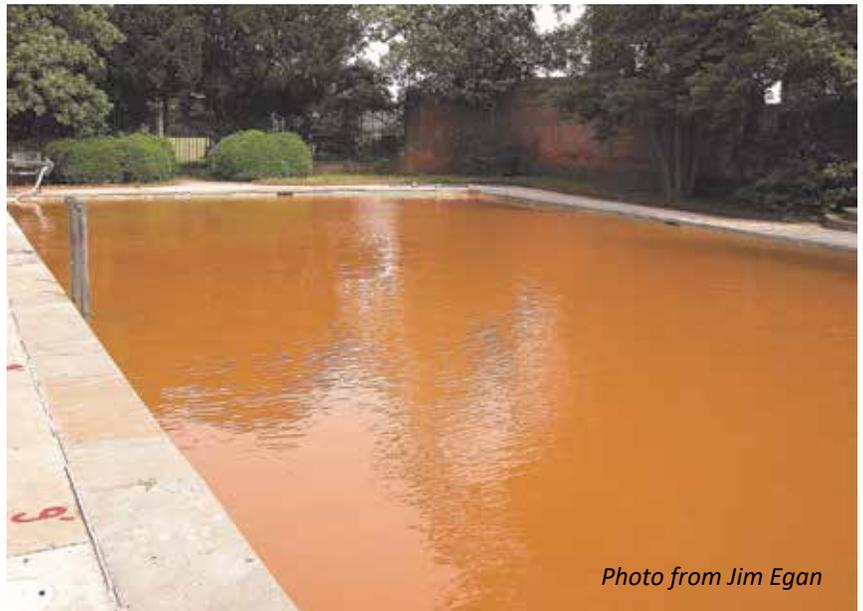
*Photo from Jim Egan*

Does anyone want to go for a swim? This photo (right) is an example of how a scary pool can happen when clear well water with a high iron content fills the pool and is shocked with chlorine.

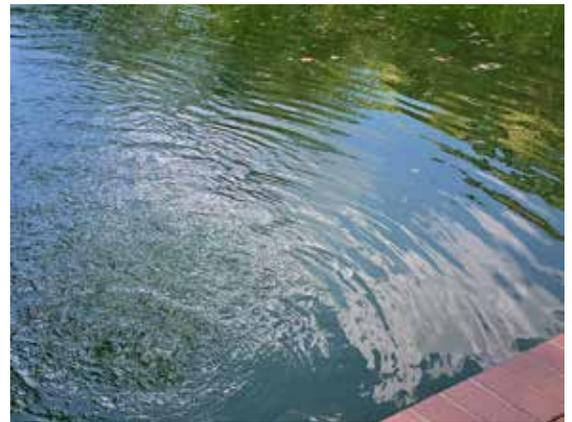
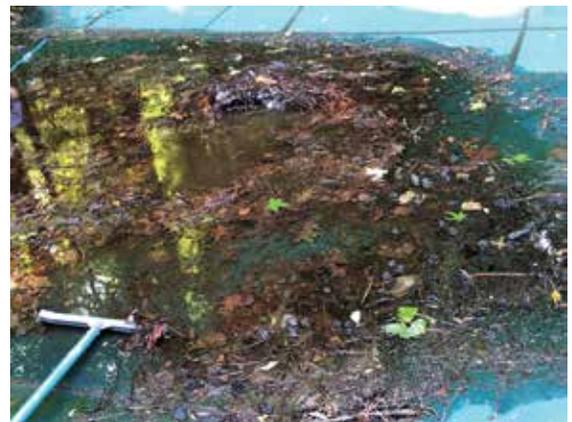
When the call comes in for service, some pools can quickly present more than a few challenges. This scary pool (right) was in an older and heavily wooded wealthy neighborhood. The elderly owner decided to sell the house and one item on his list was returning the pool to operating condition. According to the owner, the pool had been in operation the previous season. The call for service came in late June after the daytime temperature had been in the low 90s for several weeks.

Upon arrival the mesh cover was halfway covered in several inches of leaves, pine needles and sticks. Several rips in the cover permitted many pounds of leaves and debris to enter the pool. There was a considerable amount of organic material in the water. After several minutes of raking the heavy debris, it was finally possible to remove the cover. The coffee-colored water was teeming with thousands and thousands of tadpoles, some several inches long and already sprouting short legs. The tadpoles were probably why this pool was not swarming with mosquito larvae.

A close examination of the pool revealed the hillside had shifted and both skimmers were badly cracked at least halfway around. The pool had shifted so much that one skimmer was approximately two inches higher than the other. The pool was so turbid the second step was barely visible. Considering it was built before hydrostatic relief valves were routinely installed, a decision was made not to do a complete drain. When the equipment was examined, all but one of the pump's and heater's plugs were missing. Once the new plugs were installed, the pump refused to start. Eventually after an hour of persuasion, it did, only to rapidly starve for water due to air from the one skimmer being above the water level.

After both skimmers were repaired, it was possible to raise the water level and begin filtration. Water analysis showed the chemistry was roughly that of rainwater. Based on the chlorine demand of >300 ppm, it became obvious the cover had been in place for several years and the rainwater had gradually replaced all of the balanced water. The only saving grace for this pool was that both overflow outlets had continued to function. Repeated vacuuming, shocking and gradual water replacement were used to return the pool to service. Hopefully, the next owner will take better care and eventually re-plaster this classic 35-year-old beauty.
